MARK™ VIE NETWORK SWITCHES

Gas turbine, steam turbine and balance of plant Mark™ V1e and Mark™ V2e control systems

36A4940DNP516TX and
336A4940DNP517FX

GEA35433 (02/2024)

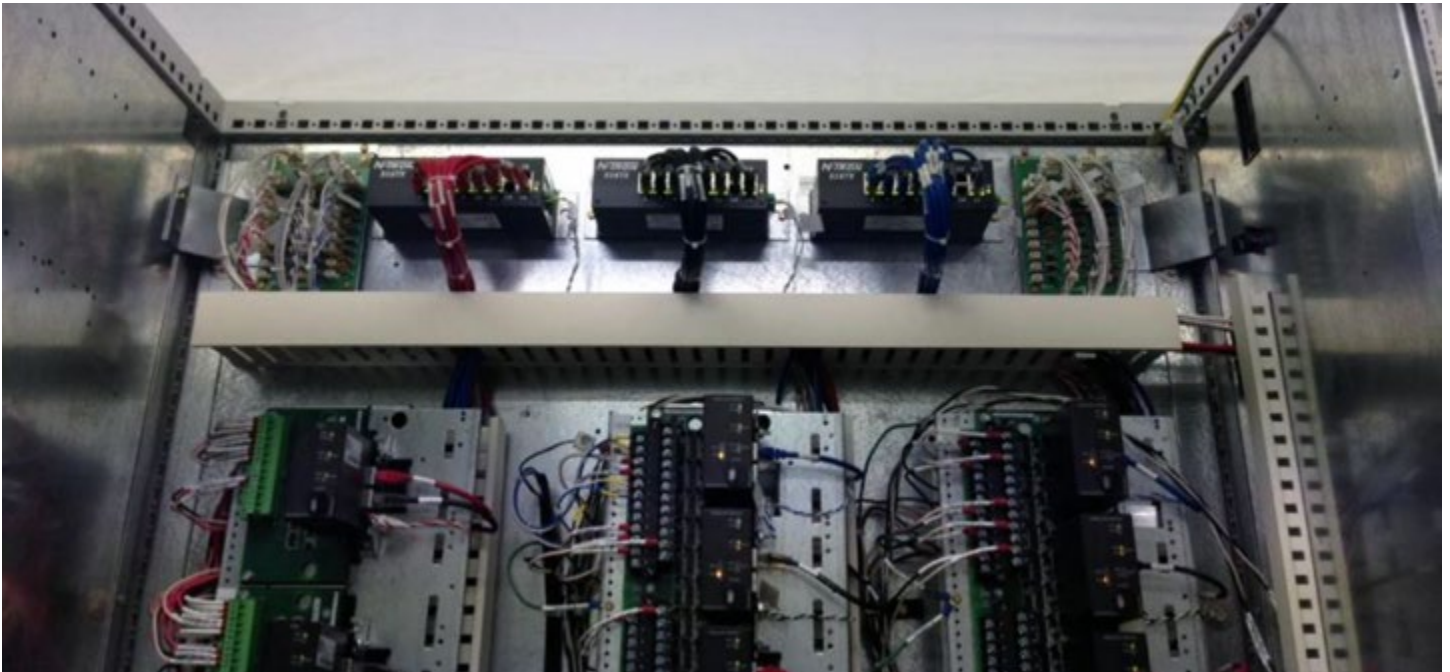
Industrial ethernet switches are configured specifically to meet demands of real time industrial control solutions. These switches provide a communication path between the main control processors and IO (input/output) packs. These network switches were first used on GE Vernova turbine control panels in 2004 and the majority of these switches continue to provide reliable service.

When network switches fail, the most common cause of failure is related to leakage of electrolyte from the power supply input capacitor. Extended exposure to higher than normal temperatures may also shorten the life of these components. In general, electrolytic capacitors are life limiting components on all electronic boards, however they can last greater than 30 years at routine operating conditions.

Symptoms of network switch failure are most likely to be a loss of all communication from a group of IO packs due to a switch reset, and subsequent loss of communication once the switch has returned to normal operation. These symptoms may repeat within a time of approximately 20 minutes to several hours. Switches using all or nearly all of the 16 available ports have been observed to be more susceptible to power supply issues. The capacitor failure mode is often accompanied by an audible hissing or crackling noise.
