HRSG Tube Restraints Upgrade

For Robust Design and Improved Reliability

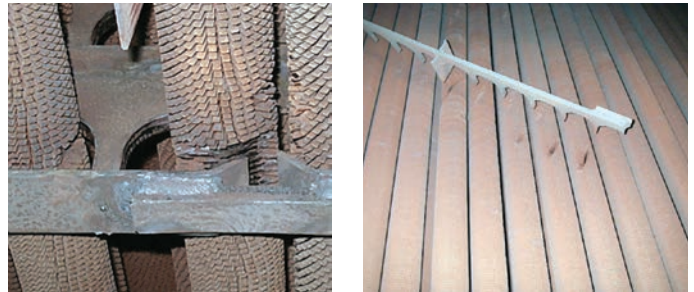
Figure 1: Fin Wear from Friction with Damaged Restraint
