Control Stage Repair Services

Control stage repair services for AEG Kanis and ABB Nuremberg steam turbines

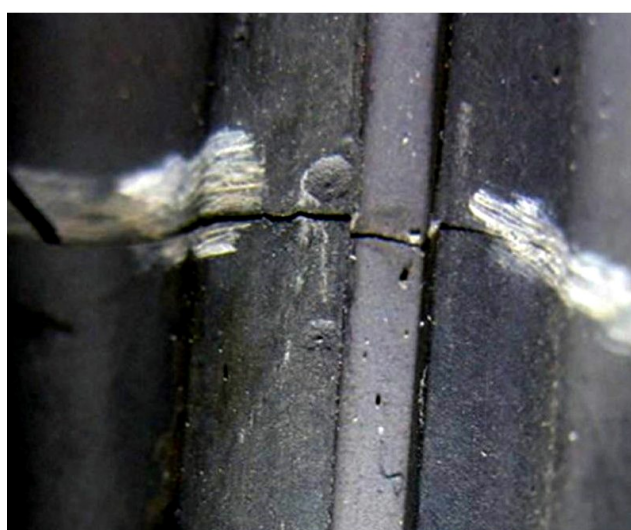
On inspection this damping lacing wire inlay is often found to be cracked (Fig. 1.). Any breakage will lead to ineffectual damping at low order vibrations. This can cause consequential damage to the control stage and even the entire turbine. A common solution is to replace the entire control stage blading and to employ a thicker damping wire.

Fig. 1: AEG Kanis G25 turbine control stage, damaged damping wire.

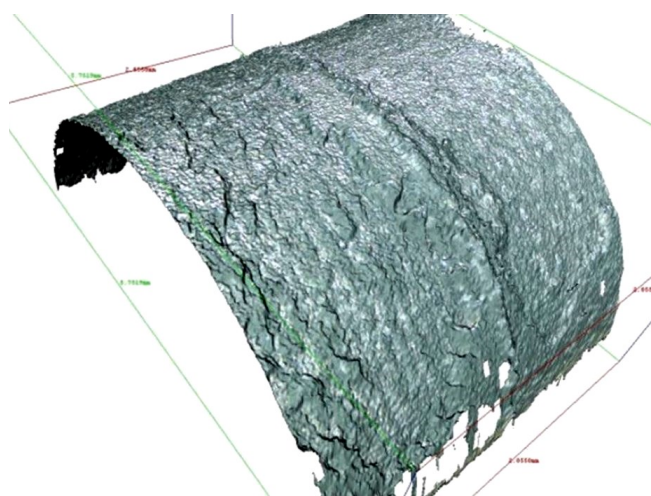
GE has carefully looked into the failure mechanism with 3D surface scans of the wire, the fracture surface and the shroud groove. The shroud groove shows fretting wear marks, the wire surface is deformed (Fig. 2.) and the cracking is primarily found at the transition between blade shrouds. Wire cracking results from the high dynamic stresses exerted on the control stage, i.e. high cycle fatigue.

Fig. 2: 3D-scan of wire surface showing material deformation (and weakening) at a shroud intersection.

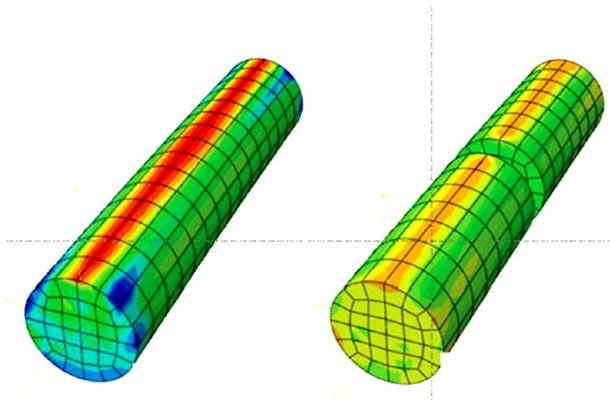
Fig. 3: Stress distribution comparison of the original wire (left) and the new segmented solution

Stress calculations (Fig. 3.) have been performed for a range of shroud and wire types using the thermal boundary conditions for turbine start-up and shutdown. These have enabled to develop a repair method using a wire that has good thermal expansion properties and is divided into sections to reduce hoop stress. The repair makes a significant improvement to the lifetime of the wire and is easy to implement within the timespan of a major turbine outage, using the nearest GE rotor workshop.

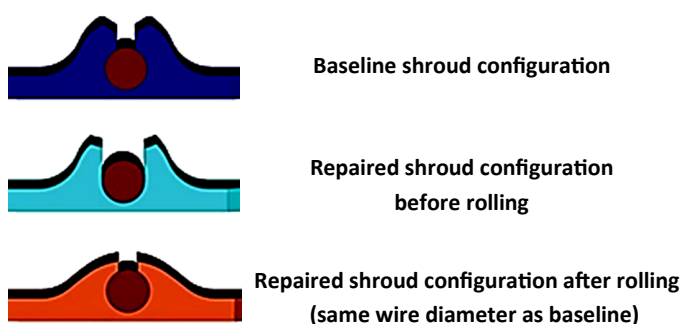
Fig. 4: Schematic of shroud and (broken) wire; cut shroud and new wire parts after rolling

The work includes removing the affected wire, cutting a new shroud geometry and rolling the new wire with splits in appropriate positions around the circumference (Fig. 4 and Fig. 5). This repair should only be applied to a control stage which is otherwise in good condition (with no cracked blades and no deformation of the wheel). However, it is also suitable for cases where the stage has already been re-bladed.

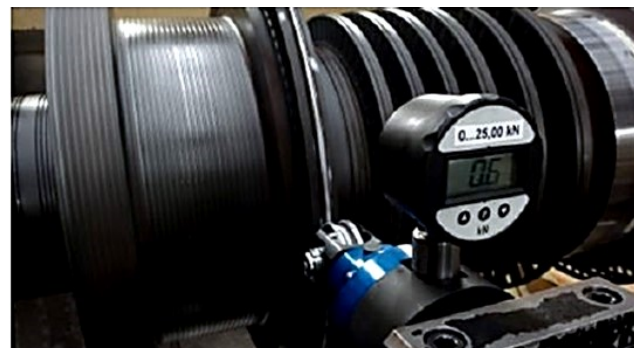
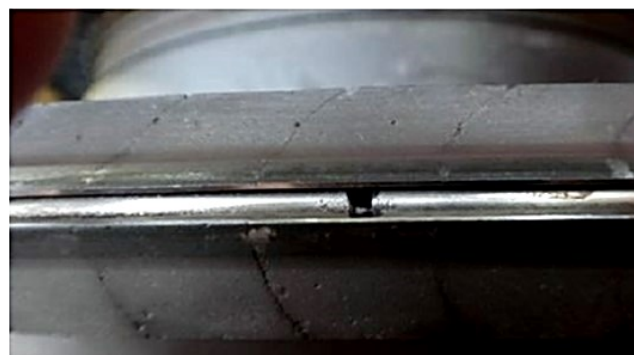
Fig. 5: Repair process: rolling-in the wire; quality check
