Control Stage Repair Services

Control stage repair services for AEG Kanis and ABB Nuremberg steam turbines

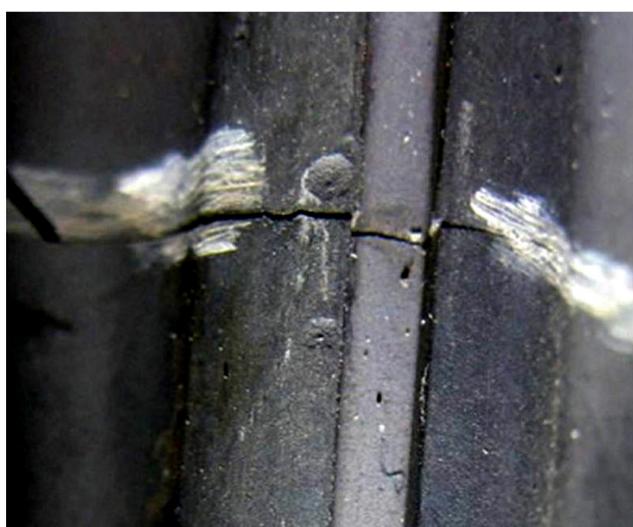
On inspection this damping lacing wire inlay is often found to be cracked (Fig. 1.). Any breakage will lead to ineffectual damping at low order vibrations. This can cause consequential damage to the control stage and even the entire turbine. A common solution is to replace the entire control stage blading and to employ a thicker damping wire.

Fig. 1: AEG Kanis G25 turbine control stage, damaged damping wire.

The work includes removing the affected wire, cutting a new shroud geometry and rolling the new wire with splits in appropriate positions around the circumference (Fig. 4 and Fig. 5). This repair should only be applied to a control stage which is otherwise in good condition (with no cracked blades and no deformation of the wheel). However, it is also suitable for cases where the stage has already been re-bladed.

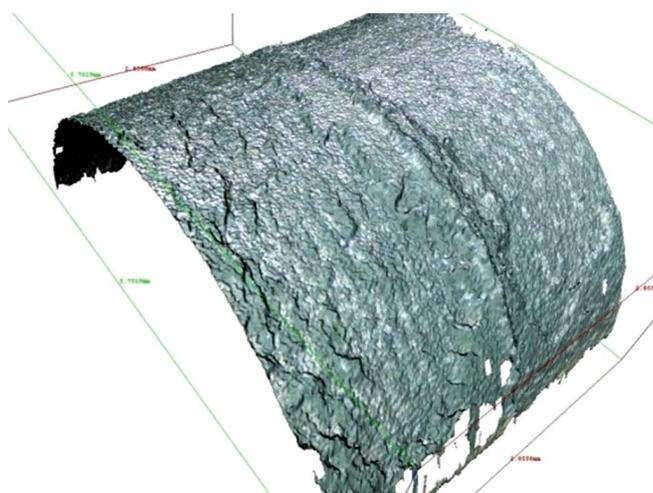
GE has carefully looked into the failure mechanism with 3D surface scans of the wire, the fracture surface and the shroud groove. The shroud groove shows fretting wear marks, the wire surface is deformed (Fig. 2.) and the cracking is primarily found at the transition between blade shrouds. Wire cracking results from the high dynamic stresses exerted on the control stage, i.e. high cycle fatigue.

Fig. 2: 3D-scan of wire surface showing material deformation (and weakening) at a shroud intersection.

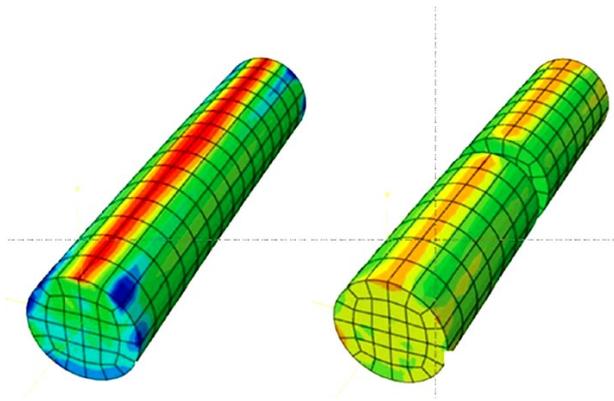
Fig. 3: Stress distribution comparison of the original wire (left) and the new segmented solution

Stress calculations (Fig. 3.) have been performed for a range of shroud and wire types using the thermal boundary conditions for turbine start-up and shutdown. These have enabled to develop a repair method using a wire that has good thermal expansion properties and is divided into sections to reduce hoop stress. The repair makes a significant improvement to the lifetime of the wire and is easy to implement within the timespan of a major turbine outage, using the nearest GE rotor workshop.

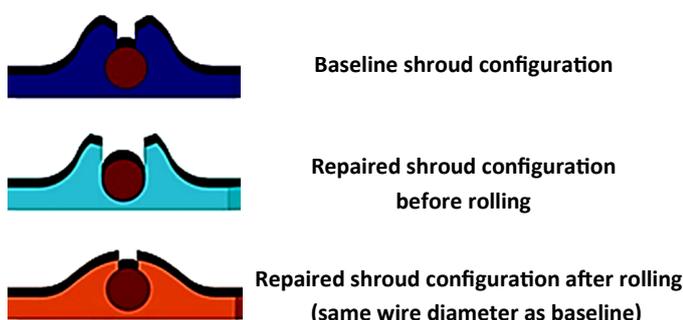
Fig. 4: Schematic of shroud and (broken) wire; cut shroud and new wire parts after rolling

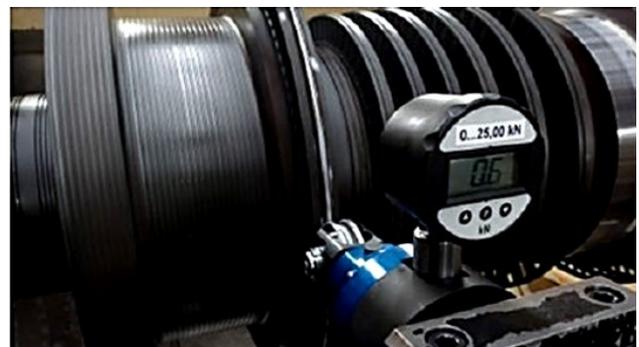
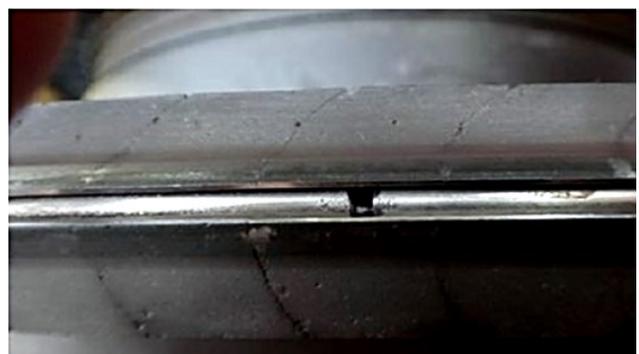
Fig. 5: Repair process: rolling-in the wire; quality check
