HRSG Casing, Insulation, Liner Upgrade

For Robust Design and Improved Reliability

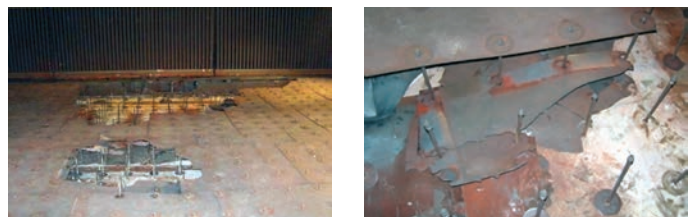
Figure 2: Damage Liner Plate and Stud Bolt from GT Strong Flow and Pulsation

It is common for the liner plate system to suffer damage during plant operation as a result of continued exposure to high exhaust gas temperature and flow disturbance. Furthermore, flexible plant operation exposes the liner system to high temperature transients increasing the risk of failure.

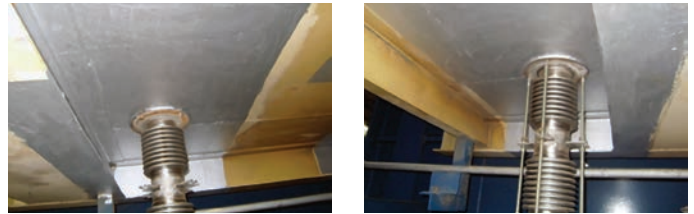
Figure 3: Heat Resistance Paint

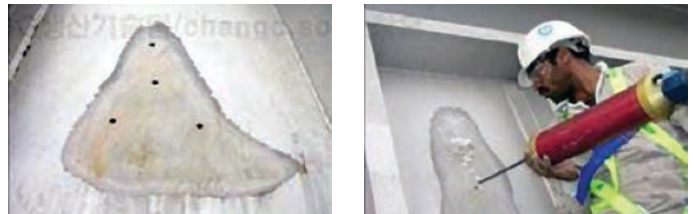
Figure 4: Re-Fill Insulation
