# When is a 28,000 pound pile of rust a good thing?

When it comes from the inside of a heat recovery steam generator (HRSG).

**GE's PressureWave Plus\* removes more than 14 tons of debris from a portion of one HRSG, resulting in \$500,000 in value from fuel savings and/or increased power generation.**

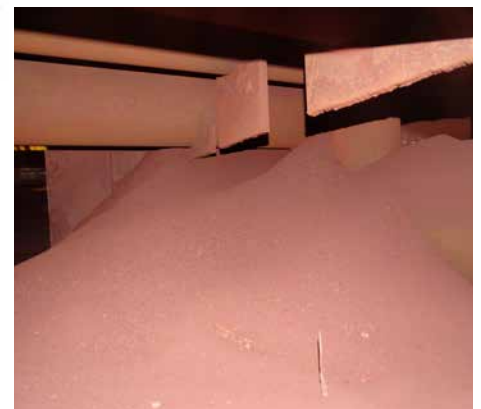
Debris after cleaning

Still seeking a solution to resolve their back pressure issue, the plant turned to GE's PressureWave Plus HRSG cleaning technology during a mini-outage in the spring of 2016. **Working six shifts over the course of three days, two crews of GE experts cleaned four modules of one HRSG, removing more than 14 tons of additional debris from the "already cleaned" unit.**

Results were immediately noticeable upon restarting the unit. Gas turbine back pressure dropped approximately 8 inches, and the stack temperature decreased 30°F. **This resulted in an estimated value of \$500,000 in fuel savings and/or increased power generation.<sup>1</sup>**

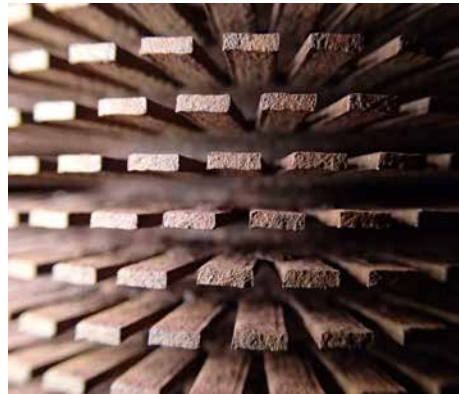
After Cleaning

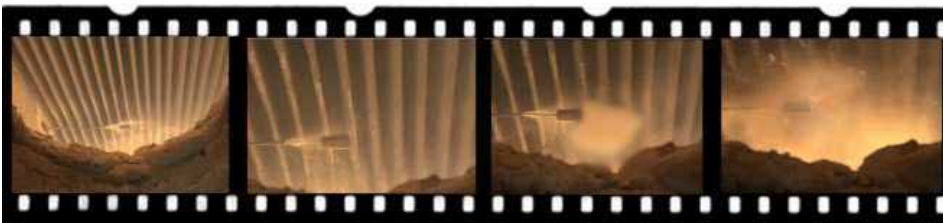
Steps in the cleaning process

Lance inserted

Bag placed in cone

Bag inflated

Bursting bag

Pressure wave cleaning is a patented technology<sup>2</sup> and process carried out with a special lance that is inserted into the access lanes between the tube bundles in an HRSG. A bag at the end of the lance then is inflated with a mixture of combustible gases that are remotely ignited. The resulting pressure wave and tube vibrations dislodge the deposits without damaging the boiler tubing. This process requires no scaffolding and entails less work in confined spaces.
