Steam Turbine Diaphragm Dishing Repair

Diaphragm Dishing Can Lead to Costly Repairs

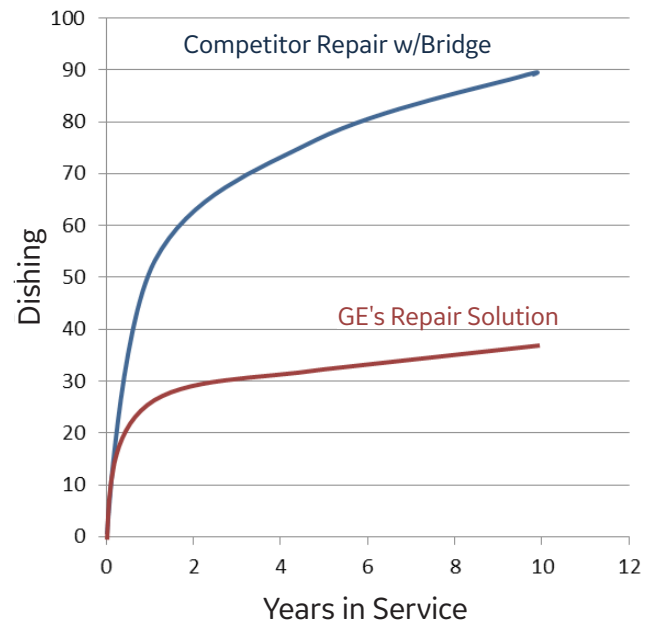
Creep Analysis

A study was performed to look at several dishing repair methods and the effect they have on long-term dishing. Using ANSYS and GE proprietary modeling techniques, the study was performed on typical third-stage HP and IP diaphragms from medium-sized turbines. A summary of the results is shown in the figure below.

The results show that GE's Power Services solution can offer just over a 50% reduction in creep over time vs. a bridge repair. Even better results were observed in comparison to pure heat straightening.
