Generator Rotor Dovetail Inspection

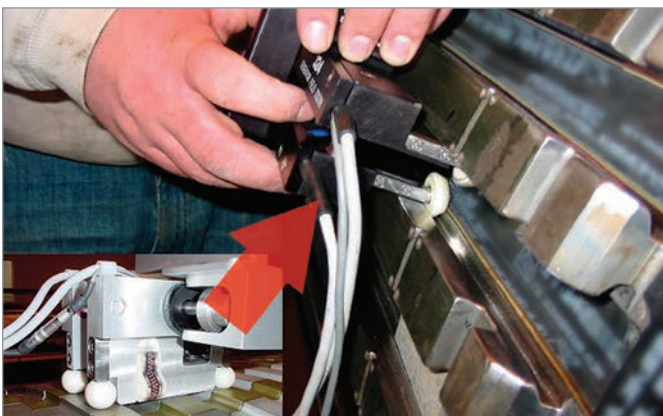
The eddy current inspection examines the entire rotor dovetail area, and can be performed during an outage after the retaining rings and slot wedges have been removed. The test employs eddy current coil arrays on both sides of a specially designed probe, built to specific rotor dovetail dimensions, to provide complete coverage of the slot dovetail geometry. This probe configuration and the equipment utilized allows the entire length of the slot to be inspected with a single scan. The data acquired is then analyzed to provide an accurate assessment of the rotor dovetail condition.

Eddy current inspection

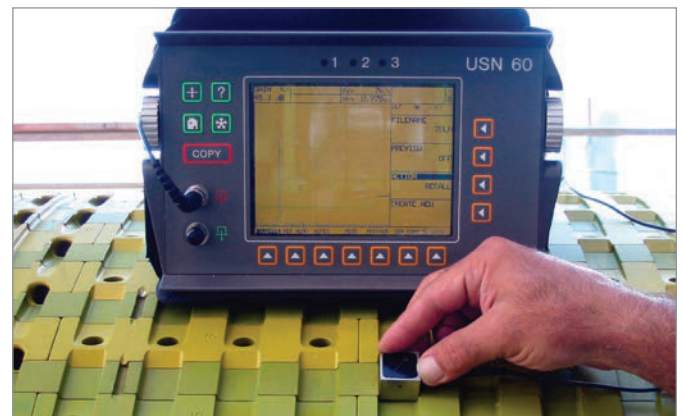
If the wedges will not be removed, an ultrasonic inspection can be performed at the wedge butt joint locations where fretting and crack initiation typically occurs. This test can be performed without removal of the retaining rings or wedges.

Ultrasonic Inspection

- UT test designed to reduce potential for false indications due to fretting damage
- UT inspection can be used to minimize operational risk until rotor is scheduled for wedge removal
- Inspection data is used to aid in developing repair options and to ensure indications have been completely removed during the repair process

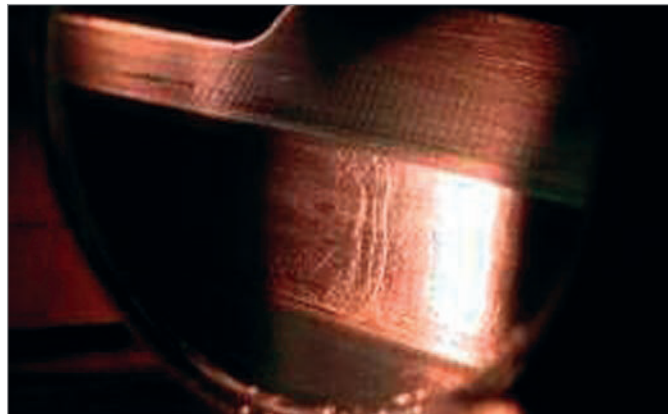
Eddy current inspection

ET	UT
Inspection Time	2 to 3 shifts (all slots)	1 shift (#1 slots only)
Detectability	> 0.005"	> 0.03"
Retaining Rings and Wedge Removal	Required	Not required
Special Preparation Required	Tape off windings and clean dovetail surfaces	No

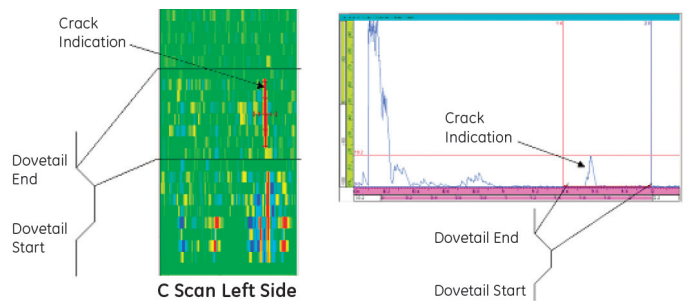
ET and UT images of the same crack
